West River Shoreline Trail/Niagara River Shoreline & Aquatic Habitat Restoration

Great Lakes Coastal and Nearshore Habitat Engineering and Design Project

**Prepared for:
Coastal States Organization**

February 28, 2023

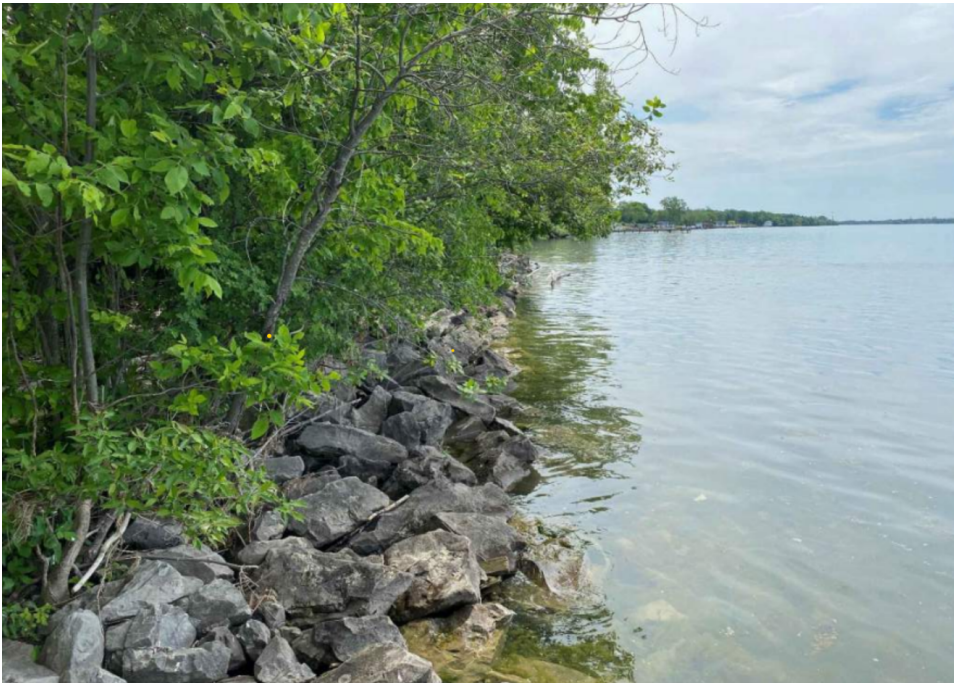
Site No 83 consists of approximately 1200 ft of shoreline with a steep, vegetated slope up to a grassy area near the trail. Rip rap lines the shoreline at the water's edge, but it appears it may be undersized and has allowed for the degradation of the shoreline.

Figure 2. Photo of undersized rip rap, Site 83

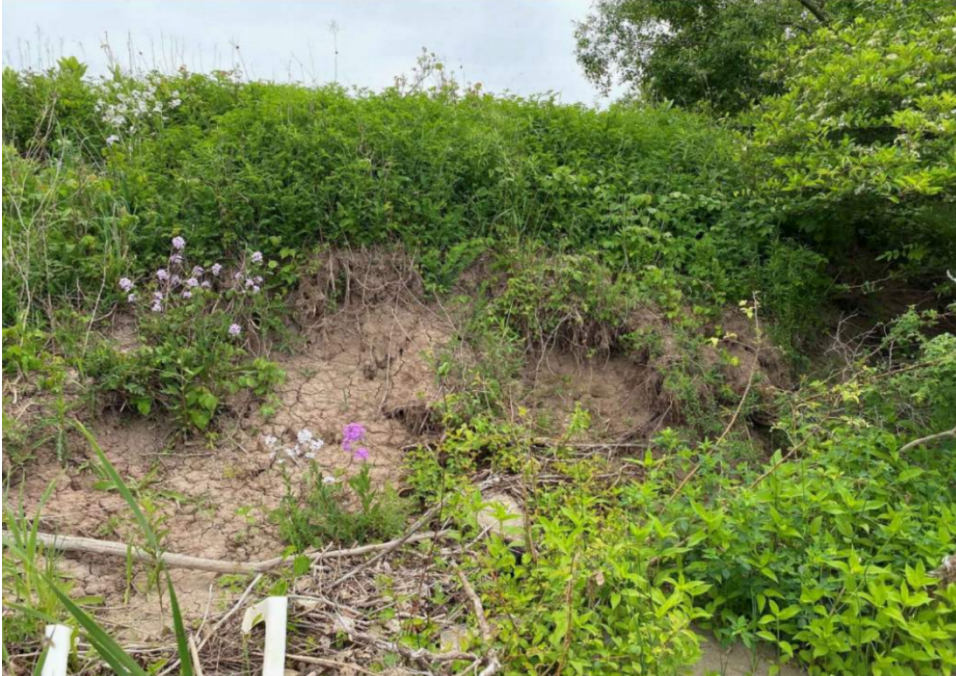
Site No 85/86 has approximately 1400ft of shoreline, also with a steep vegetated slope with no rip rap toe protection. The riverbanks are showing signs of erosion and slope instability.

Figure 3. Photo of slope failure along the shoreline, Site 85/86

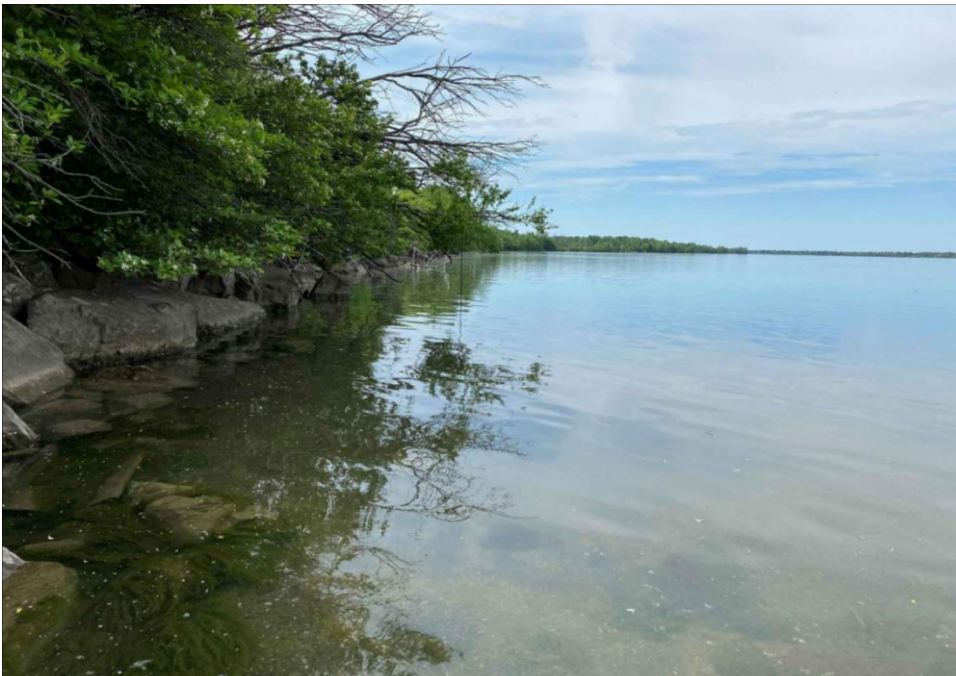
Site No 91 has approximately 600ft of shoreline, also with a steep vegetated slope. Site No 91 has intermittent rip rap along the toe of the slope. Failure of the rip rap is likely due to the lack of interlocking properties of the stone.

Figure 4. Photo of rip rap along shoreline, Site 91

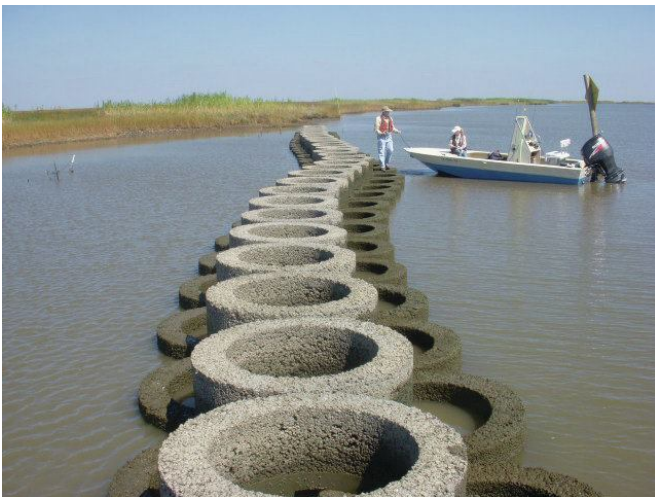
There are several proprietary concrete wave attenuation systems which have been proven effective at dampening wave energy and protecting shorelines. An example of such a system is provided in **Error! Reference source not found.**

Figure 12. Concrete ring wave attenuation system (Image from Wayfarer Environmental Technologies)

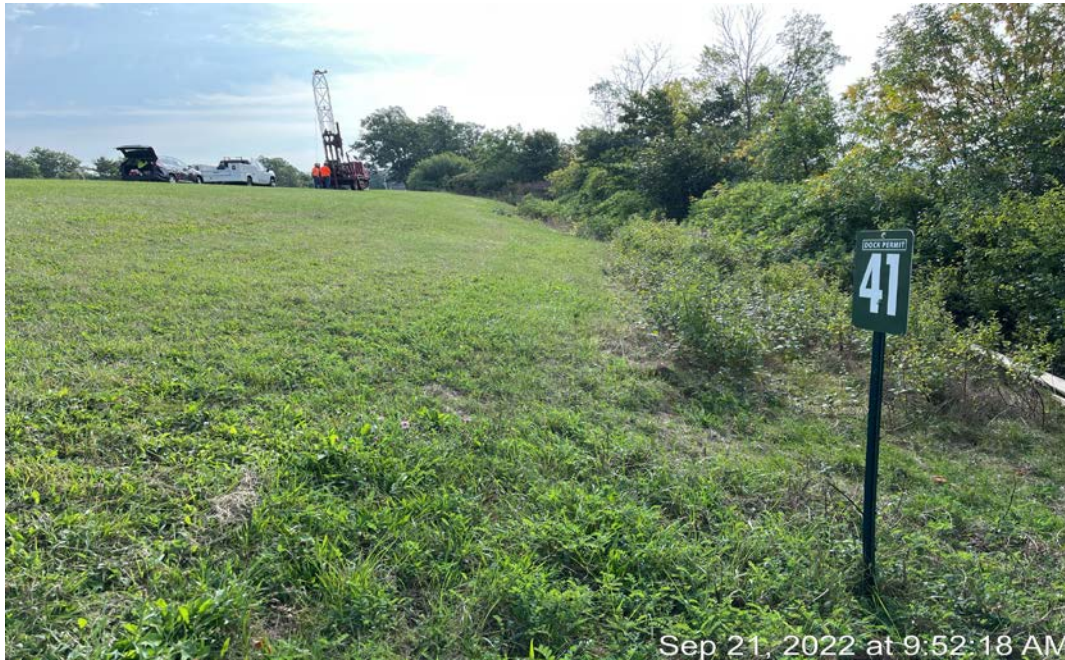
Photo 1 - Drill rig set up near crest of slope at Site No. 83. Photograph view toward south taken from NYSRHP dock site permit 41.

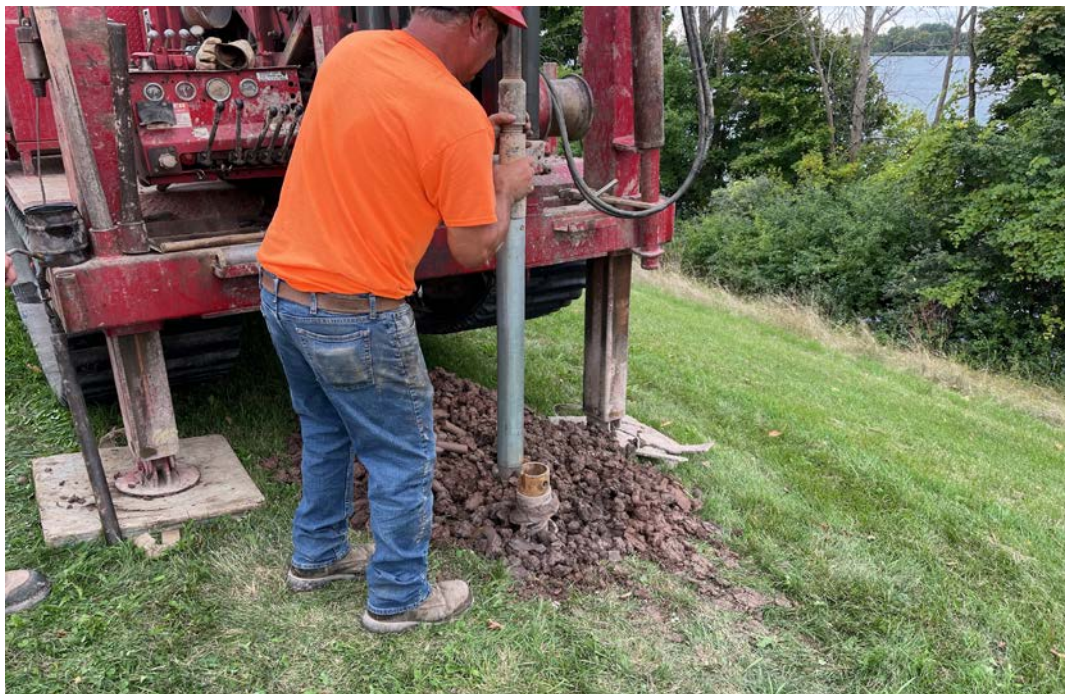
Photo 2 - Subcontracted drillers retrieving undisturbed (Shelby) tube sample from B-2 at Site No. 83.

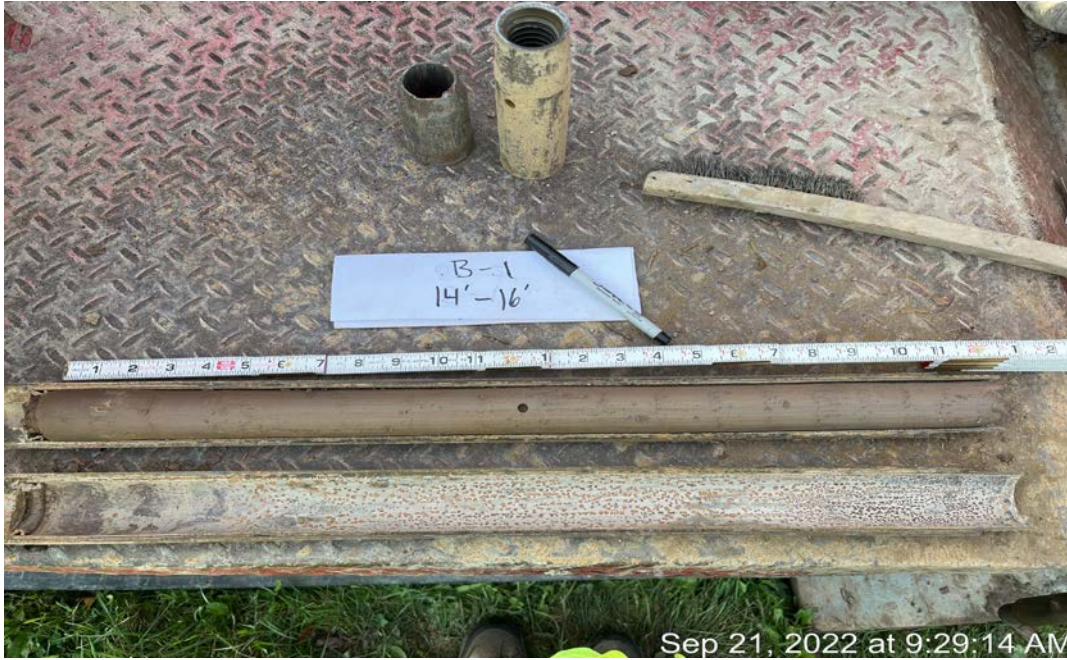
Photo 3 - Recovered split spoon sample from test boring, showing recovered core sample of Silty CLAY.

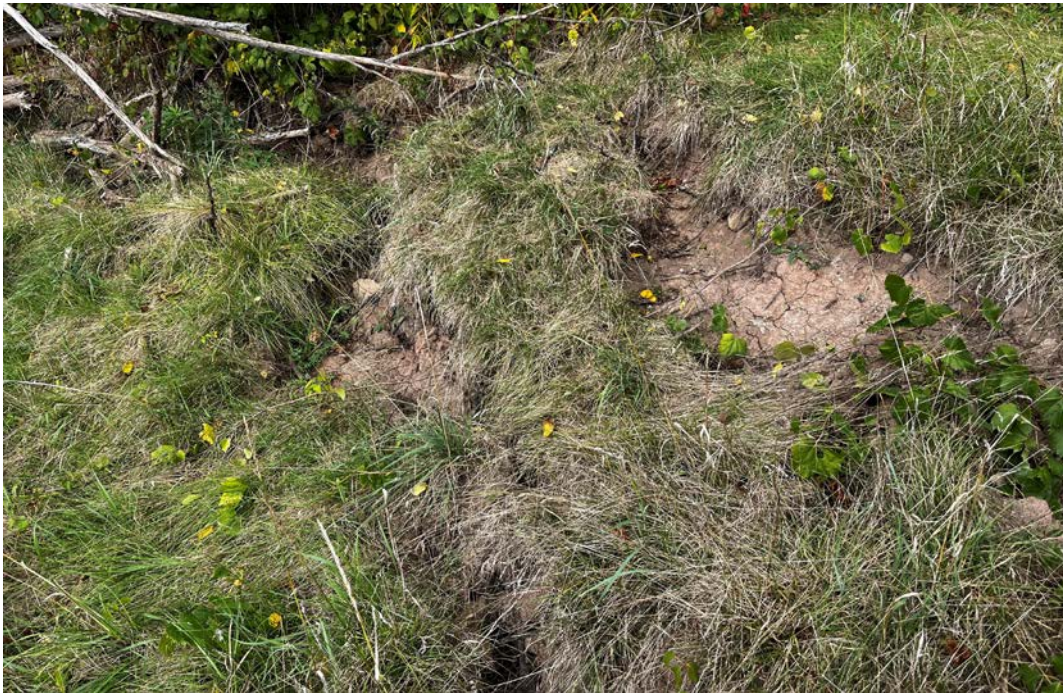
Site No. 85+86 has approximately 1,400 feet of shoreline length, which is unprotected. The slope at the site is steep, and narrow gravel beach is exposed along the shoreline. The crest of the sites slope is approximately 50-feet east of the water's edge, and the slope is covered with vegetative brush from the shoreline to the crest of the slope, beyond the crest is open lawn maintained by NYSPRHP. Directly beneath the slopes crest is a scarp face indicative of previous slope failures, as well as several tension cracks orientated parallel to the shoreline.

Photo 4 - Tension cracks observed in clay soil slope at Site No. 85+86.

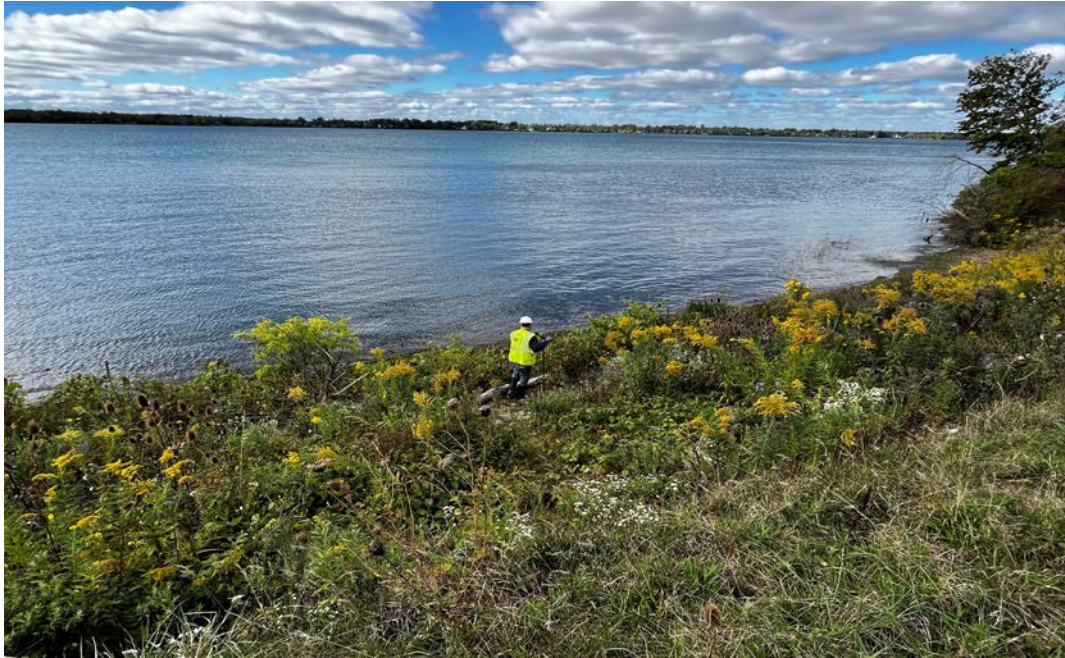
Photo 5 - GZA Engineer collecting hand auger soil samples near shoreline at Site No. 85+86.

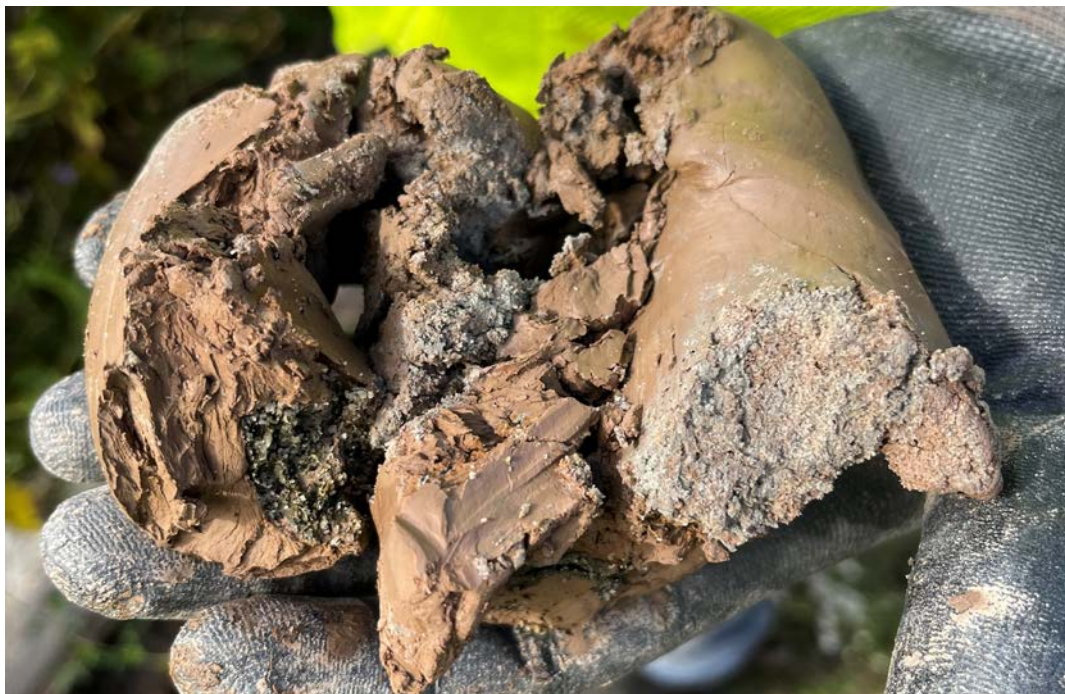
Photo 6 - Recovered soil sample from hand augering near shoreline at Site No. 85+86. Confirmation of Silty CLAY soils up to a depth of 7-feet below ground surface.

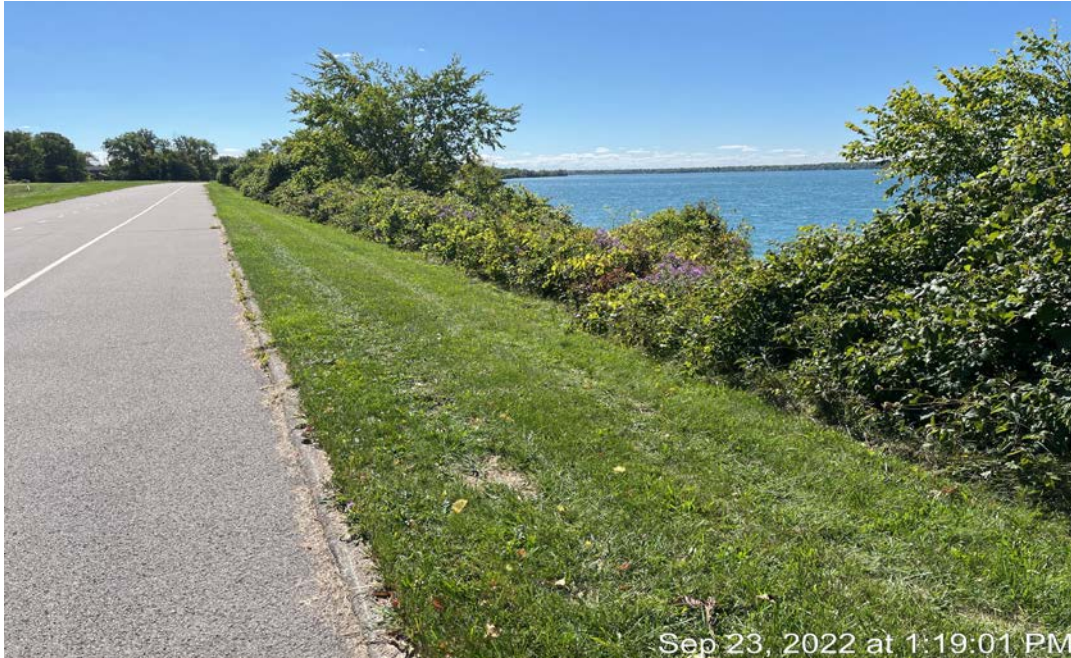
Photo 7 - View to the south at Site No. 91. Note Vegetative scrub-like brush at crest of slope.

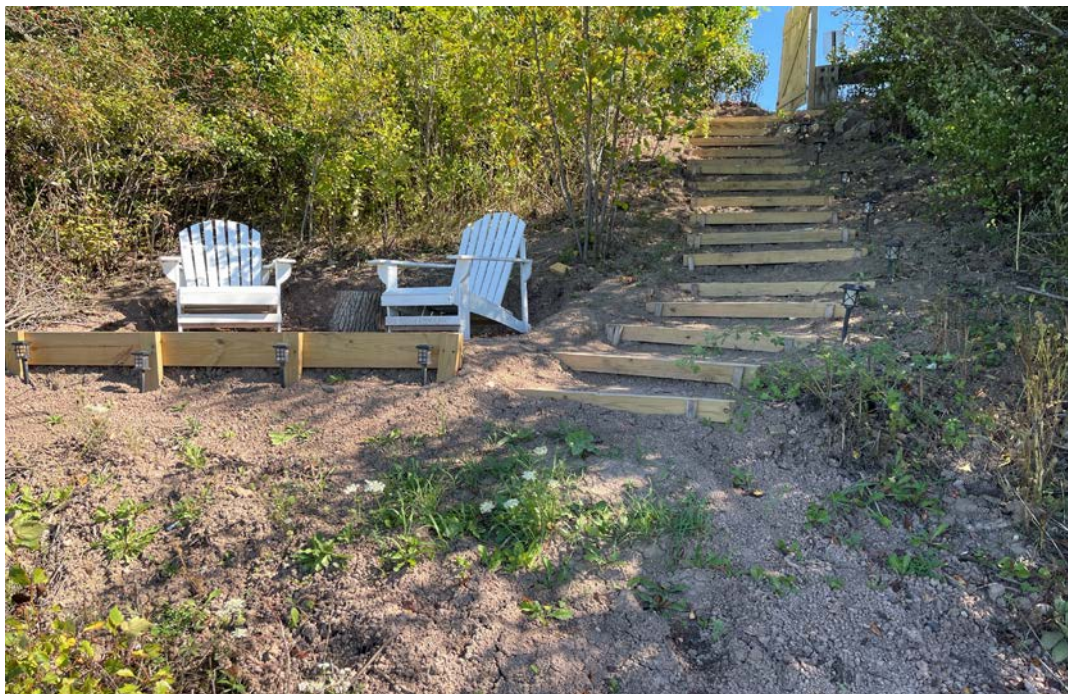
Photo 8 - Note exposed clay along slope at Site No. 91.

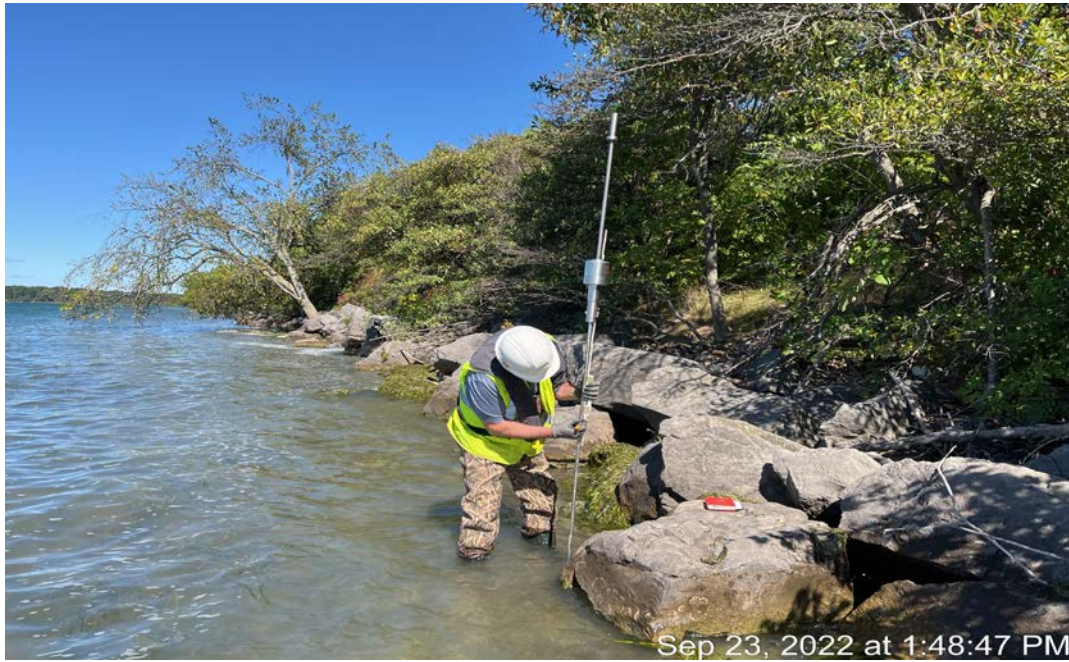
Photo 9 - Performing Dynamic Cone Penetrometer (DCP) test at Site No. 91. Note armor stone along shoreline.

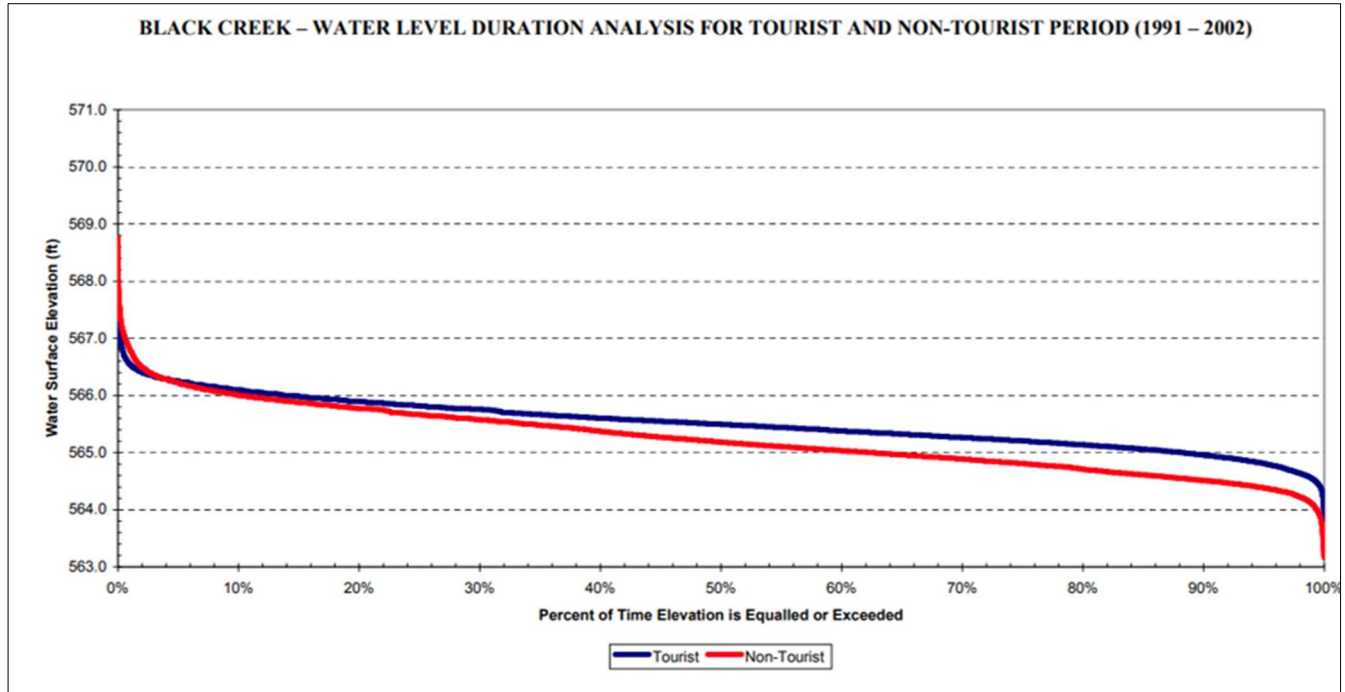
Based on the water level duration analysis by URS at Black Creek, Figure 5 shows the percent exceedance for water surface elevations during the tourist and non-tourist seasons.

Figure 5. Water Level Duration Analysis at Black Creek (URS, 2003)

According to the chart, the water levels are 566.0 feet International Great Lakes Datum of 1985 (IGLD85) for 10% exceedance during both tourist and non-tourist timeframes. For 90% exceedance, the water levels are 565.0 feet (tourist) and 564.7 feet (non-tourist). During our Grand Island site survey on August 25, 2022, the water level was 565.05 feet.

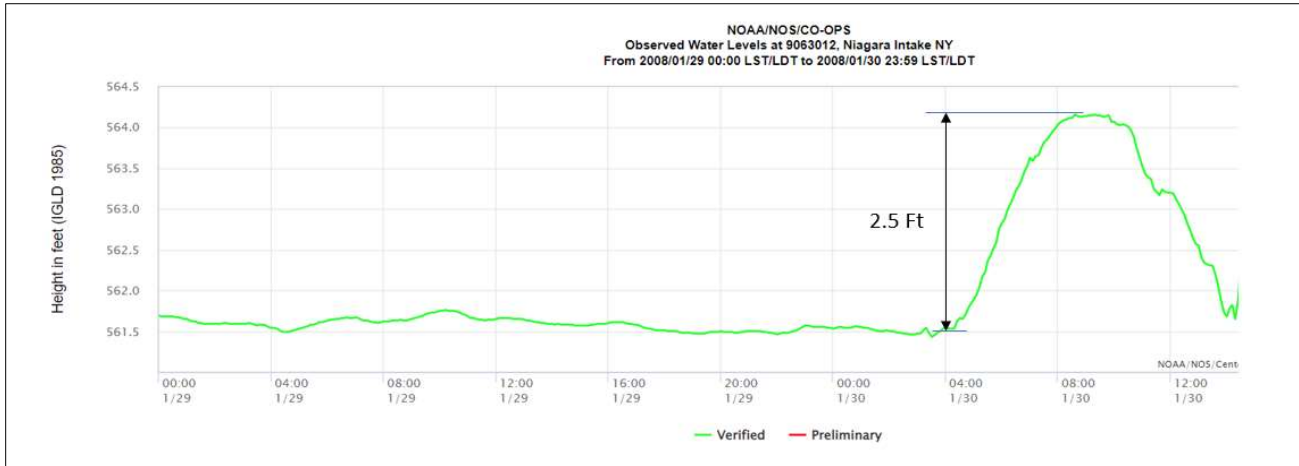
A review of recorded seiches on Lake Erie indicates a typical water level increase of 5 to 7 feet in Buffalo, with as much as 9 to 10 feet, while the USGS and NOAA gauge locations show 2 to 3 feet. These are reflected in the daily recordings by the water level gauges. Figure 6 shows an example of a recorded significant seiche on January 30, 2008, that produced a water level increase of 9.4 feet at the Buffalo location and 2.5 feet at the Water Intake location.

Figure 6. Lake Erie Induced Seiche at the Water Intake (NOAA Gauge 9063012)

The impacts of seiches, therefore, are attenuated downstream the river. Based on the data reviewed, the expected water level increases in the project areas due to Lake Erie seiches are in the range of 2 to 3 feet, well in agreement with previous studies.

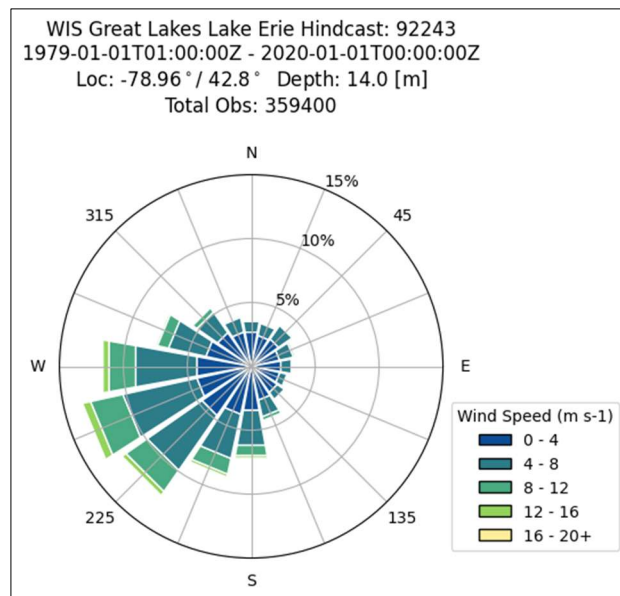
Based on the Lake Erie long fetches (distances over the open lake) from the west and southwest, significant waves and storm surges are produced by storms at the Buffalo location. They will be limited downstream of the river at the Grass Island project locations. A wind rose was downloaded from the Wave Information Studies (USACE), as shown in Figure 7.

Figure 7. WIS Buffalo Station 92243 (USACE)

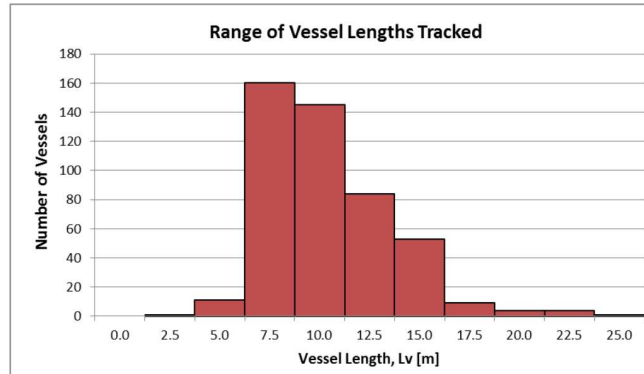
The longest recreational vessel at these marinas is 47 feet (14.3 meters). The typical vessel length ranges between 25 and 40 feet (7.6 to 12 meters). Both the largest vessel and the typical range were well represented in the US Naval Academy study (see Figure 8).

Figure 8. Lengths of Boats Studied (US Naval Academy Maryland, 2012)

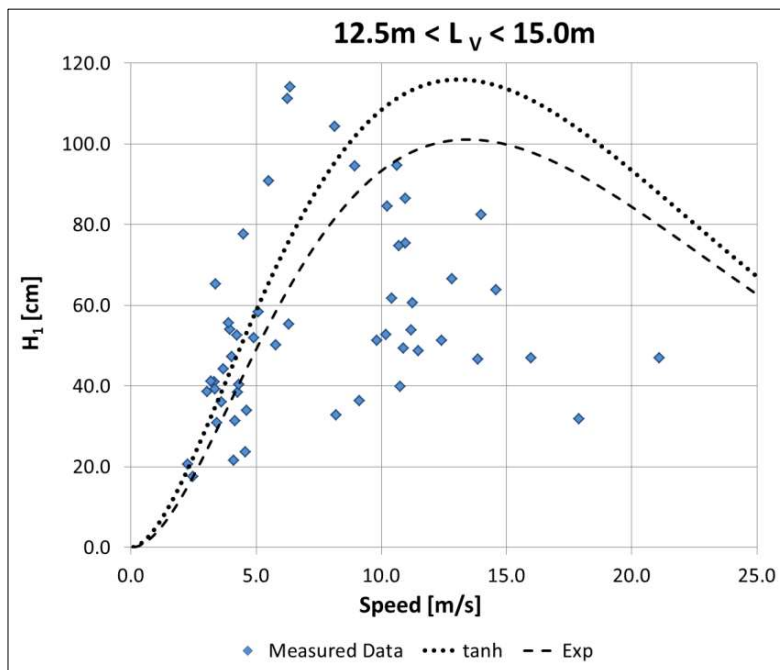
Using the US Naval Academy's charts for the longest boat present in the regional marinas (47 feet, 14.3 meters) (see Figure 9), the recorded vessel traveling speeds varied between 2.5 meters per second (m/s) (5.6 mph) and 22.5 m/s (50.3 mph). As these are extreme minimum and maximum values recorded by only three out of 471 vessels, they were discarded from our analysis. The average speed of all vessels is 11 m/s (24.4 mph), with the recorded boat wakes values being as follows:

- Minimum = 0.4 meter (m) (1.3 feet);
- Maximum = 0.92 m (3.0 feet); and
- Average = 0.64 m (2.1 feet).

Figure 9. Boat Wake Plot (US Naval Academy Maryland, 2012)

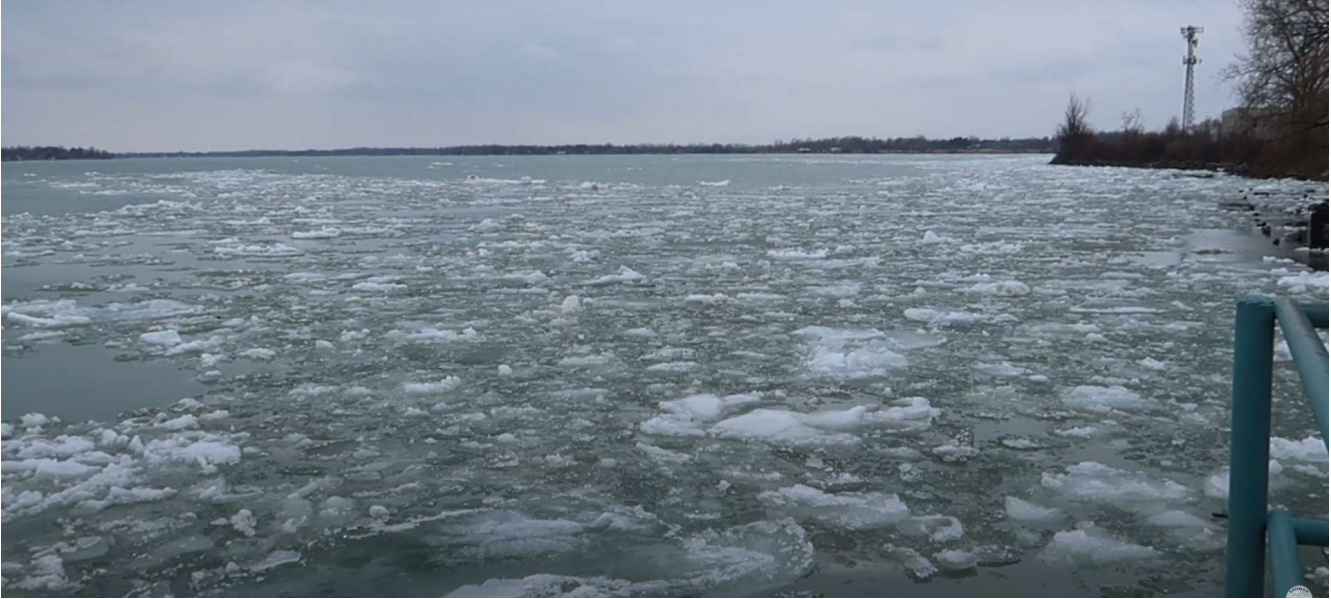
Under normal conditions, the placement of the ice boom in the vicinity of Buffalo provides ice-free conditions on the Niagara River. Even when submerged due to high winds, the boom still attenuates the ice movement and runs on the river. USACE documents the river ice conditions immediately after removing the ice boom. Based on various video files reviewed, there are no ice jams on the river, but the movement of ice flows along the shoreline can still be significant for a few days, as shown in Figure 10 (April 10, 2022 at the Raymond Klimek Veterans Park).¹ No significant ice ride-up (ice accumulation on the riverbank slopes) was documented.

Figure 10. River Ice Movement (April 10, 2022, Raymond Klimek Veterans Park)
