## **Whistler Woods Riparian Restoration**

Portion of the shoreline to be stabilized: The south bank of the Little Calumet River along Whistler Woods Forest Preserve from Halsted east to the Little Calumet River Bridge, aka the Major Taylor Trail. 41.65705, -87.641108 to 41.657712, -87.63076. It is about a half mile of riverbank

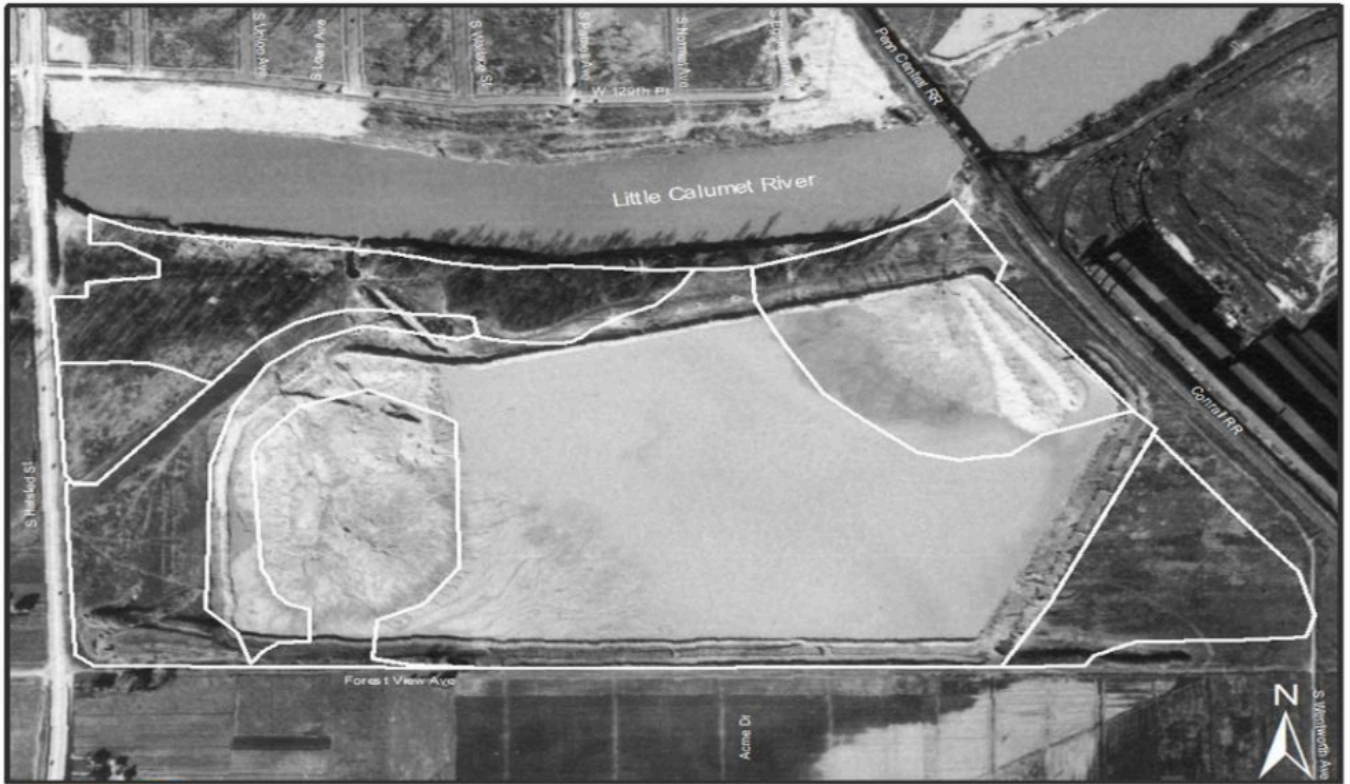
- Most of this material is likely sand and silt-sized sediment (Kay et al. 1997).
  - Aerial photographs from 1938 (Figure 1/See below) verify the presence of large spoil piles along the western and northeast edges of the site (USGS1938).

- In fact, the entire central portion appears to be a scraped, disturbed area lacking in vegetation. This dumping ground “was soon forested by volunteer cottonwood seedlings” (Mann 1965).
